# DESIGN AGAINST KERB-CRAWLING: TIPPELZONES (vice zones)

## European Experiences in Displacement

**Presentation for The International CPTED conference, September 13-17<sup>th</sup> 2004,  
Brisbane Australia**

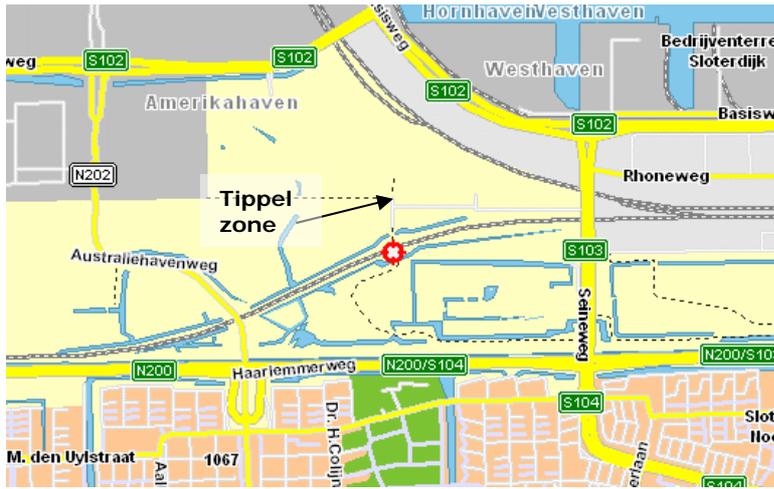
**Figure 3:** *Toppelzone Amsterdam*

*NB: Note that there are no residential areas nearby, only infrastructure (e.g. railroads, highways, etc)*

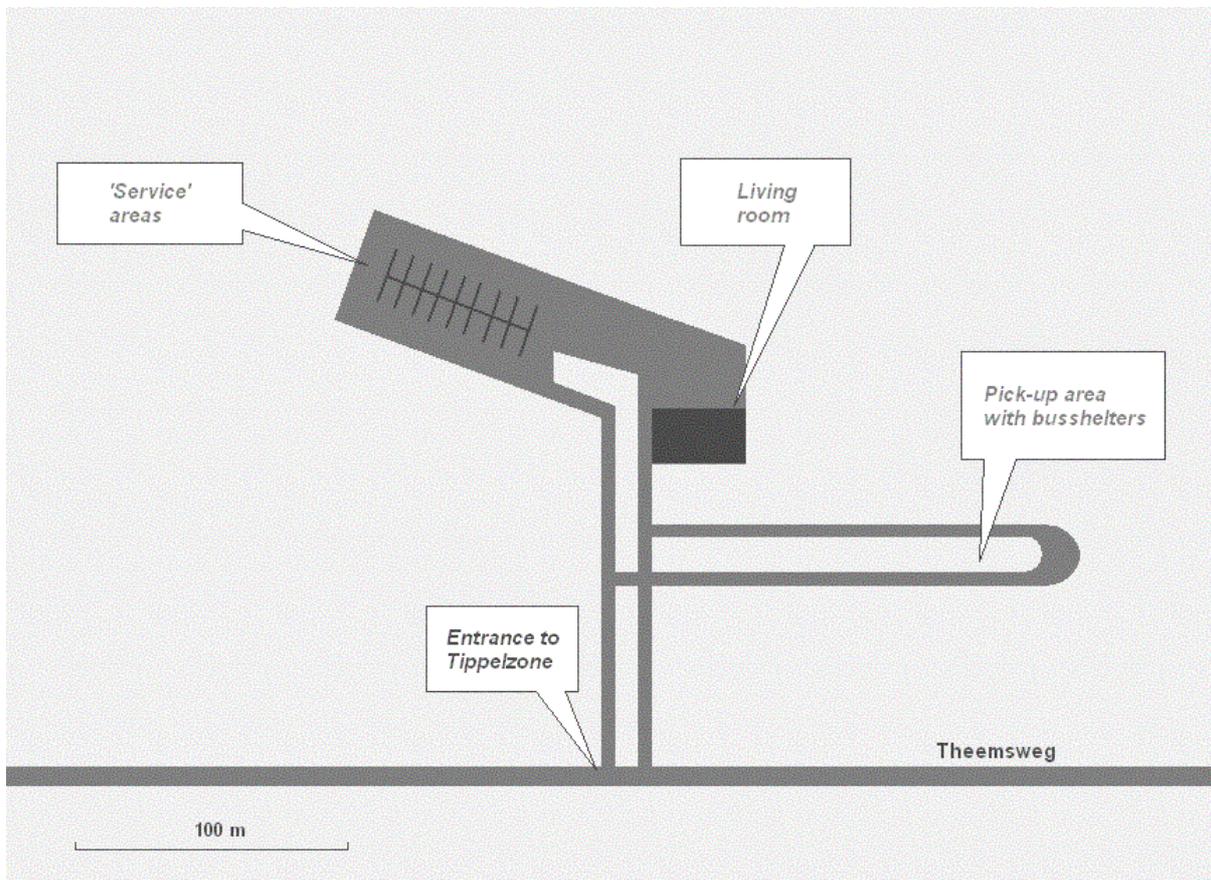
**Figure 4:** *Layout of the Amsterdam Toppelzone*

Four of the eight Toppelzones in Dutch cities are used as normal streets during the day. This is the case in Utrecht, Den Haag, Groningen and Nijmegen. The other four cities have a zone that is closed and fenced off during the day and open during evening and night hours. The Toppelzone in Amsterdam is an example of the latter category. It consists of a fenced-off area with two U-shaped roads connected in the middle (see figure 4). The first loop is an area where customers can look at, negotiate with and pick-up prostitutes. Bus shelters provide protection from bad weather and this part of the zone is fairly well lit (see figure 5).

Following the 'pick-up loop', there is a shelter, the so-called 'living room', which houses a number of services for the prostitutes. In Amsterdam, this is a two-storey building with an entrance at the front for the prostitutes and an entrance at the rear for care-workers and other staff. The most important part of this building is the actual living room where prostitutes can buy some food, non-alcoholic drinks and condoms. They can also take a shower, use the restrooms or just relax on the couches or chairs. Two nights a week, a medical doctor is present in the living room where prostitutes can go to get information or help concerning medical issues. Upstairs, an observation room has been built where police, care-workers or researchers can study the proceedings outside without being seen by customers or prostitutes. In the back of the building, some offices are present for administrative purposes and there are some storage facilities.

Next to the living room are 24 "afwerkplekken" or service-areas. Each compartment is fenced off on three sides by aluminium plates, mounted in such a way that they do not reach the ground. This is to avoid giving the impression of complete seclusion and thus improves safety. Each compartment has a litterbin to the left of the car, which effectively prevents the driver from opening the door on the driver's side whilst parked (see figure 6<sup>4</sup>). The door on the prostitute's side, however, can be opened giving her the opportunity to leave the car if needed. There is a special, smaller "afwerkplek" for customers arriving by motorcycle or even by bicycle.

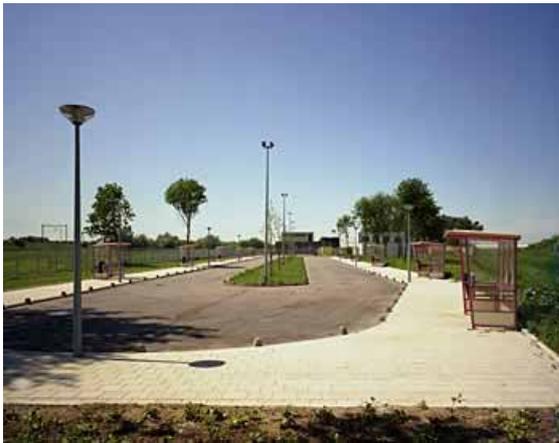
**Figure 5:** *Tippelzone Amsterdam – the 'pick-up' loop with bus-shelters*

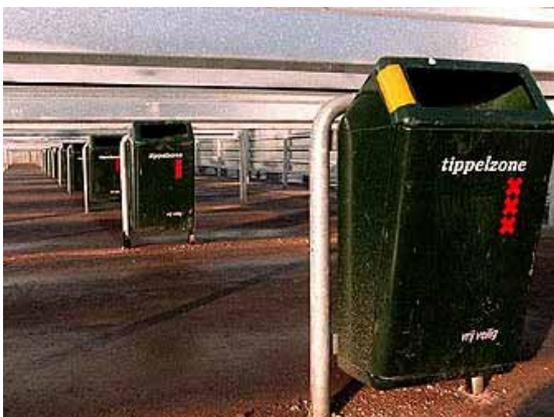
**Figure 6:** *Amsterdam Tippelzone – the parking spaces as seen from within*

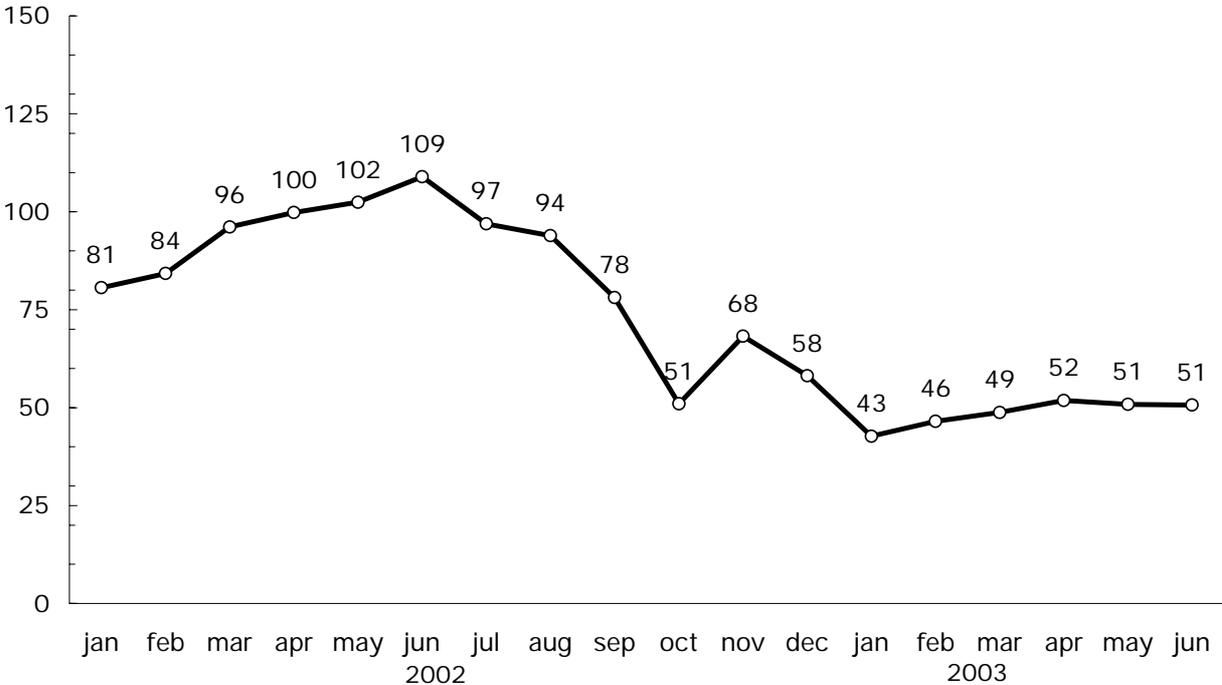
**Figure 7:** Mean number of prostitutes per night in the Toppelzone living room January 2002 to June 2003 (absolute numbers)

During the summer months of 2002, according to both the police and staff of the living room, the situation at the zone became impossible to handle. During busy nights, the number of prostitutes working at the zone could number up to 150, when it was originally designed to accommodate a maximum of around 80 (see figure 7). This led to dangerous situations in the zone and to intolerable levels of competition among prostitutes. Fights for customers started among prostitutes, and customers and pimps alike took advantage of this chaotic situation. Care workers from the living room alerted the authorities, including the police, and asked them to help find a new balance. The number of prostitutes was considered to be too high for the zone and the number of incidents of trafficking women was alarming. The illegal status of most of the prostitutes presented too many possibilities for extortion, mistreatment and exploitation of these women.

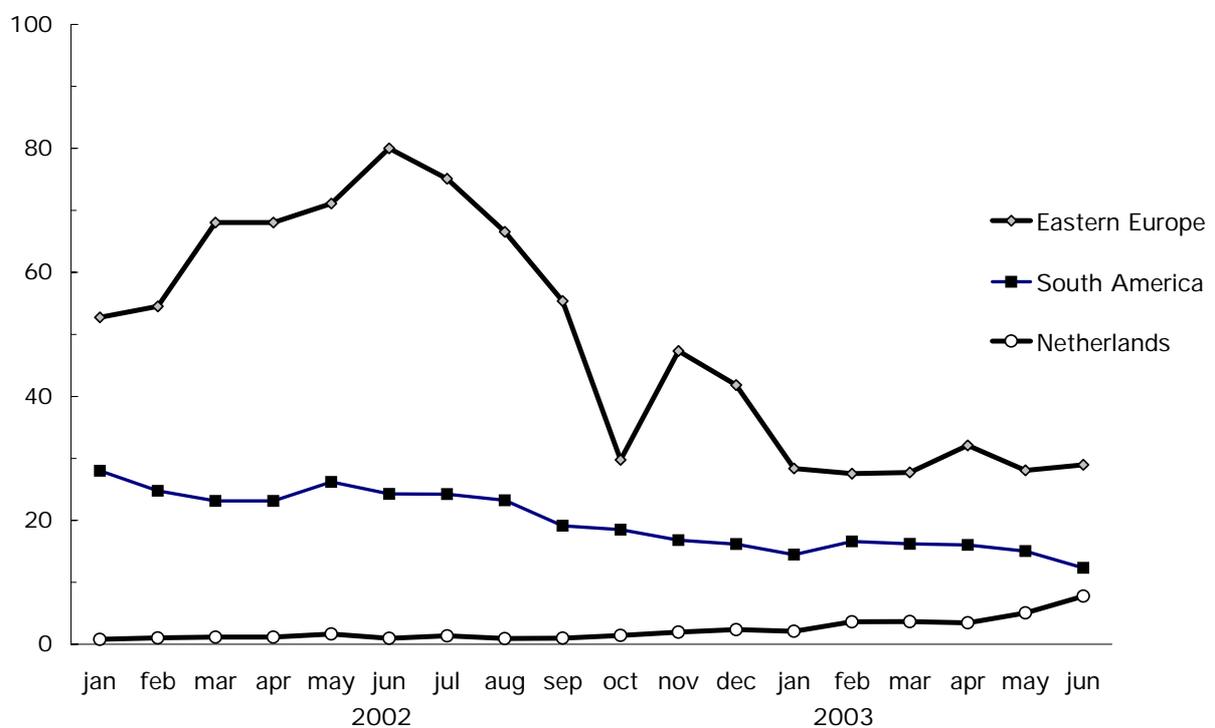
**Figure 8:** Country of origin prostitutes: January 2002 to June 2003 (absolute numbers per night)

The most visible and drastic actions taken, however, were two large-scale police raids in September 2002 and January 2003—the effect of which can be observed in figure 8. During these actions or 'sweeps', the police checked the legal status of all prostitutes in the zone. Illegal immigrant prostitutes were immediately transported to the airport and flown back to their home countries. Following the first sweep, 97 prostitutes were repatriated mainly to Bulgaria, Albania and Romania. After the second sweep, 67 women were flown home, mainly to Bulgaria, Romania and Ecuador. In the time between these large-scale actions, the police checked hundreds of women during regular shifts and banned many of them from the zone for a designated number of days. The police actions had a notable effect on the East European group of women especially (see figure 8).
